Site Inspection Report

Orderville, Muddy Creek Gemstone Leases:
ML 19890, ML 26996, ML 27618, ML 41354 & ML 41355

Date of Inspection: June 13 & 14, 2000
Persons Present: William M. Stokes
Tom Munson, DOGM
Loy Crapo
Mike Crauso
Conditions: Hot, Dry & Clear
Lands Inspected: E $\frac{1}{2}$ NW $\frac{1}{4}$, Section 36, T. 40 S., R. 8 W., ML 19890
NE $\frac{1}{4}$ NE $\frac{1}{4}$, Section 36, T. 40 S., R. 8 W., ML 26996
NW $\frac{1}{4}$ NW $\frac{1}{4}$, Section 36, T. 40 S., R. 8 W., ML 27618
SW $\frac{1}{4}$ NW $\frac{1}{4}$, Section 2, T. 41 S., R. 8 W., ML 41354
W $\frac{1}{2}$ (including lots 1-9, 14-16) Section 31, T 40 S., R. 7 W., ML 41355

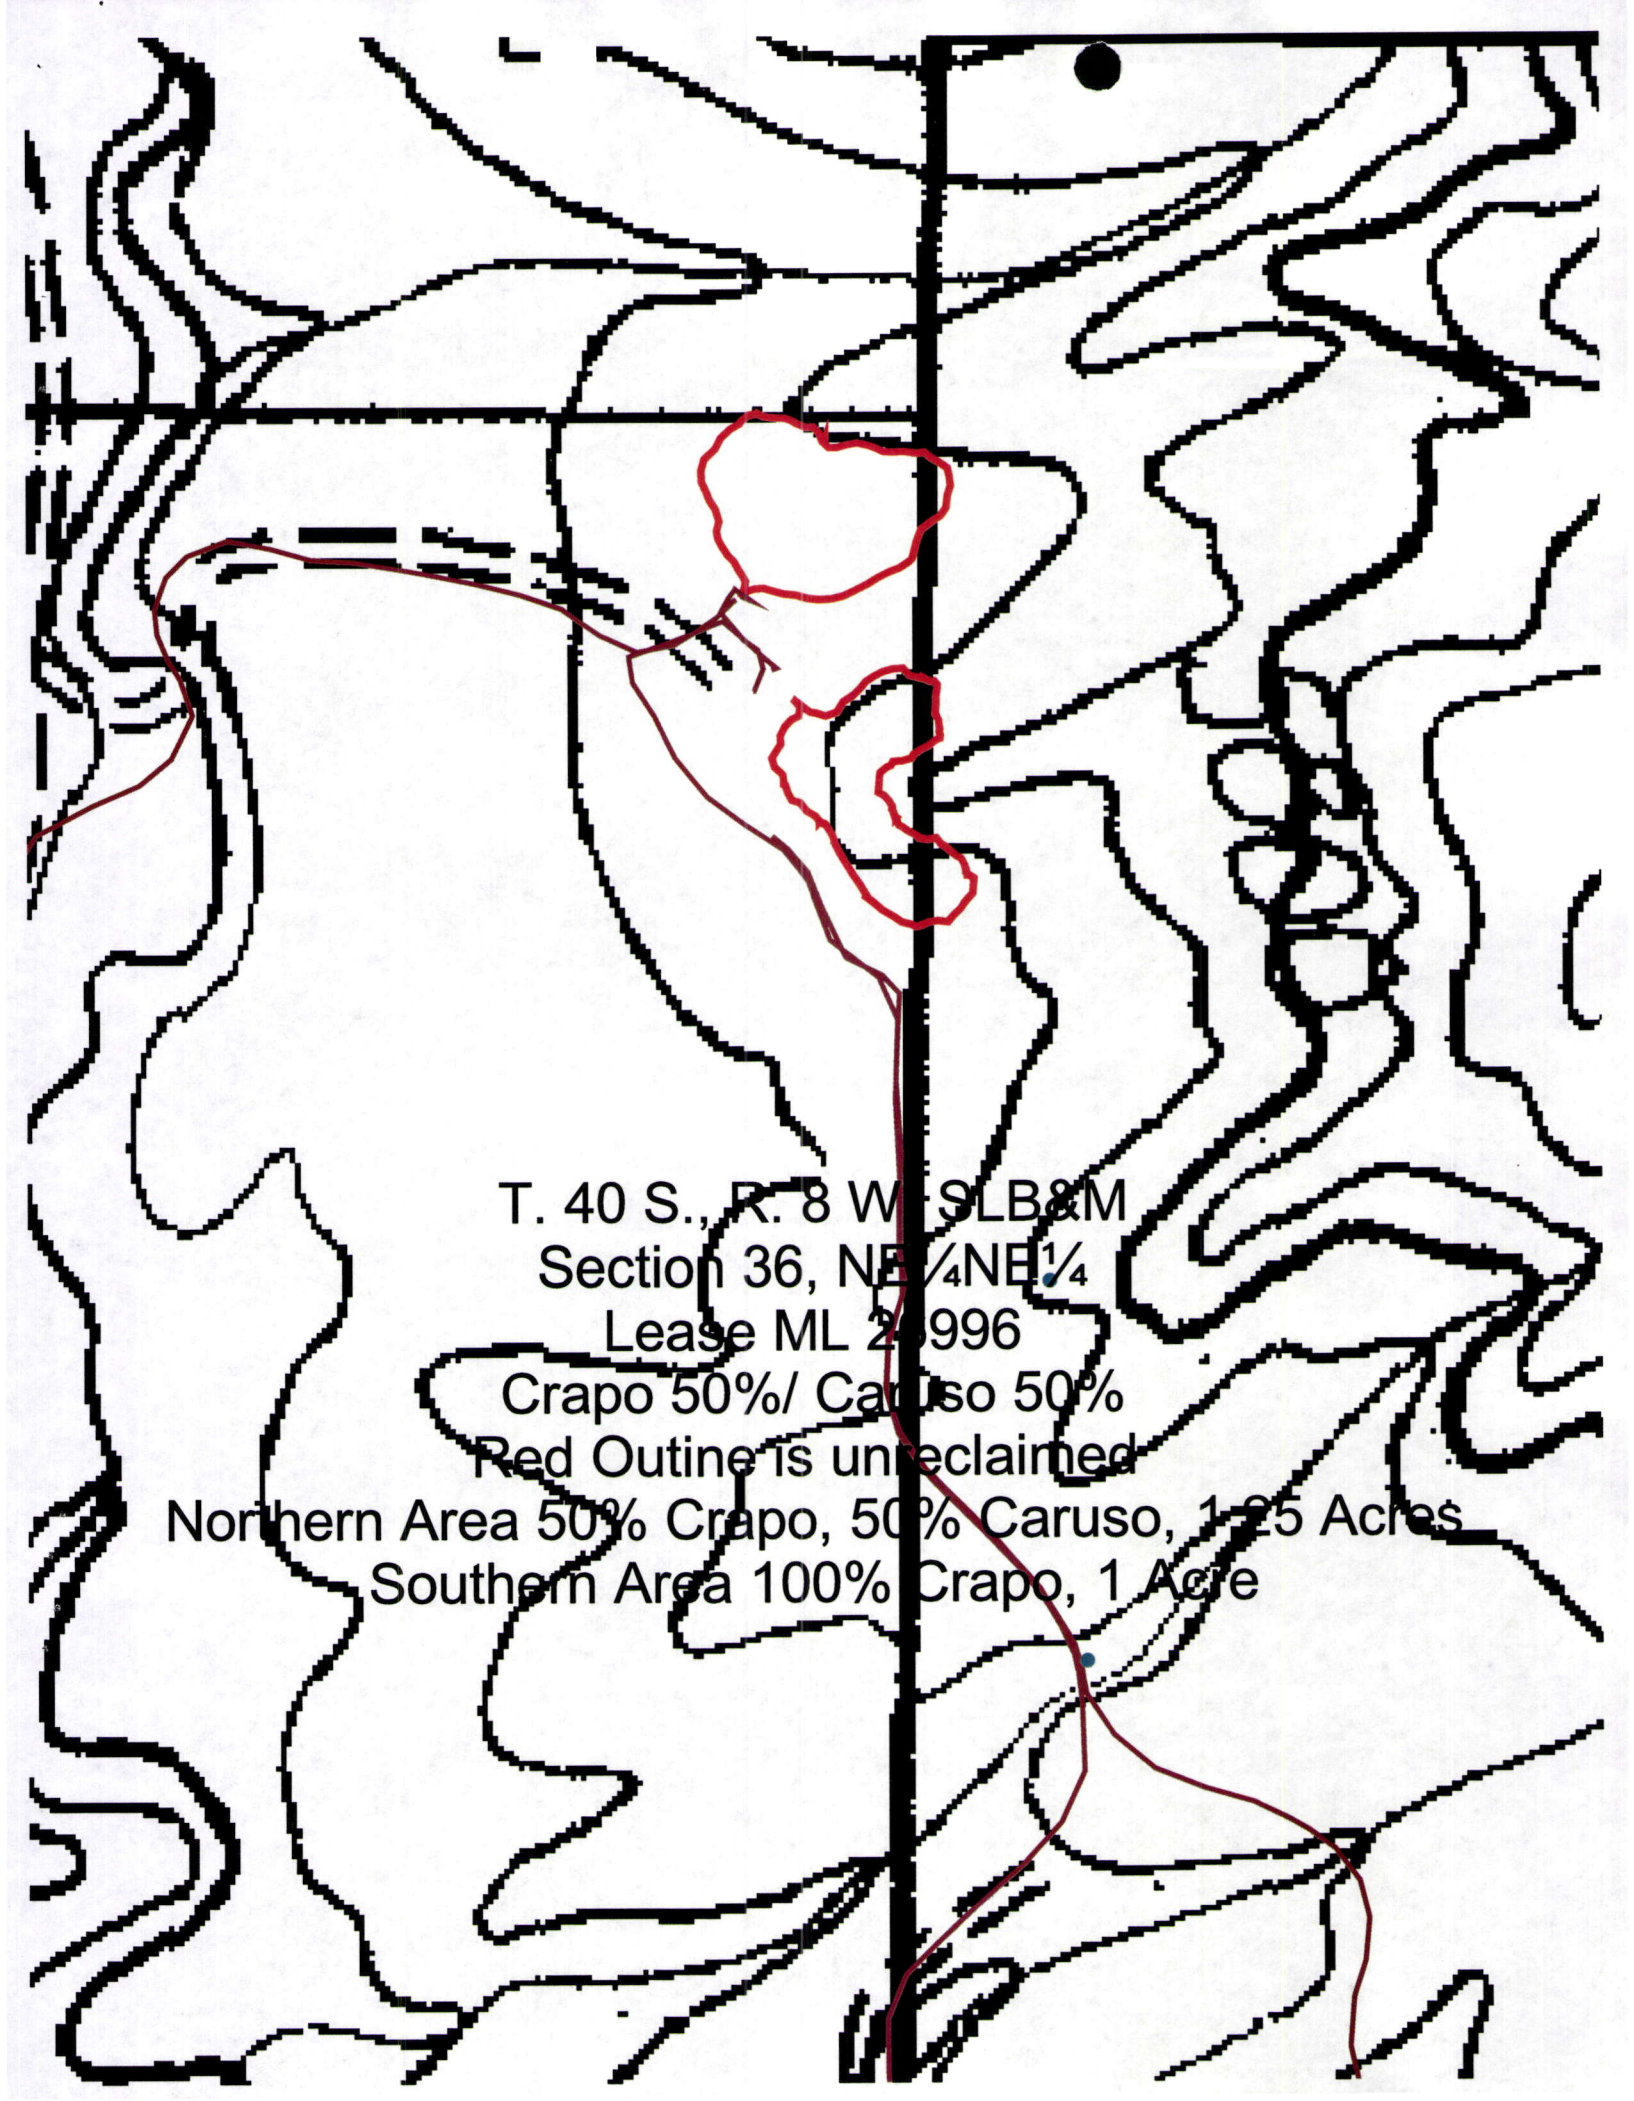
T. 40 S., R. 8 W. SLB&M
Section 36, NE $\frac{1}{4}$ NE $\frac{1}{4}$
Lease ML 26996

Red Outline is unclaimed

Northern Area 50% Crapo, 50% Caruso, 1.25 Acres

Southern Area 100% Crapo, 1 Acre
